**ENVIRONMENTAL CONDITION OF PROPERTY  
REPORT FOR THE PROPOSED SALE  
OF THE SOUTHEAST PARCEL  
FORT BLISS, TEXAS**

The purpose of this Environmental Condition of Property (ECP) is to document the environmental condition of the Southeast Parcel, the Subject Property, slated to be sold on Fort Bliss, Texas.

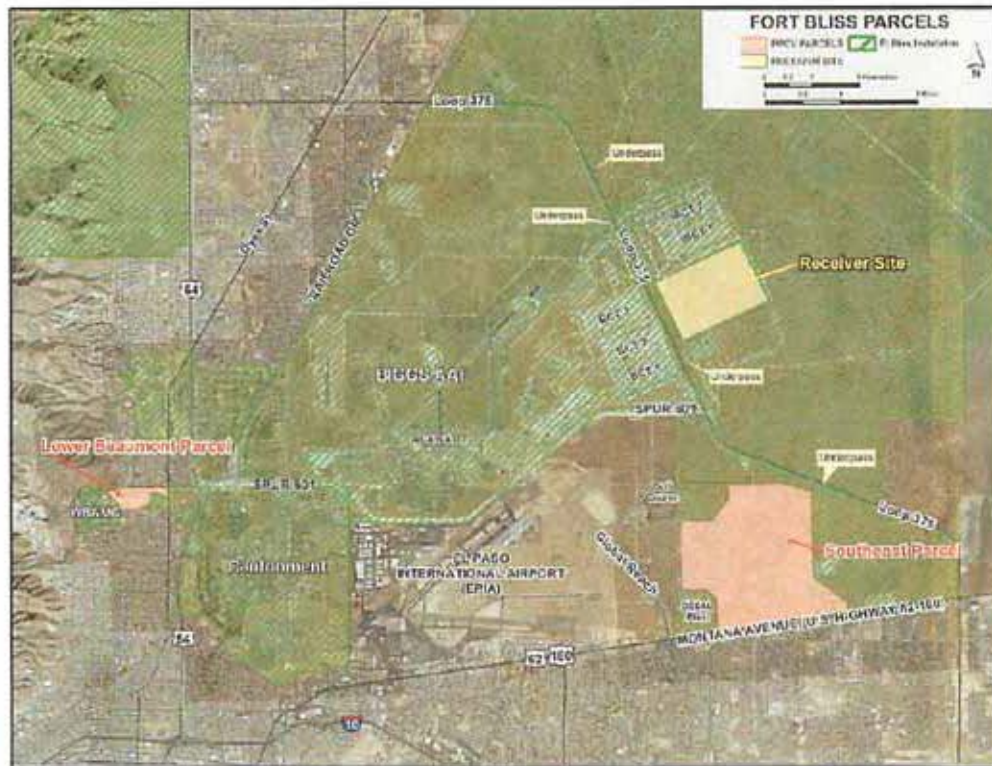
Figure 1. Location of Southeast Parcel (Subject Property).

The Subject Property consists of approximately 1,635 acres of mostly undeveloped land within the U.S. Army Garrison of Fort Bliss, Texas (Figures 1 and 2). The site is north of Montana Avenue and southwest of Purple Heart Boulevard (Loop 375) and is bounded on the west by the El Paso International Airport. The new East Bliss El Paso Community College is slated for construction to the northwest, and the Desalinization Plant is located to the southwest. The property has been under military jurisdiction since 1939, and the majority of the area has been used for military training in maneuvers. A small FAA facility which is no longer used is located in the eastern portion of the parcel (Area B in Figure 2). This facility is on approximately 8.5 acres and consists of two fenced areas: one containing a structure with two small sheds and the other enclosing a cement slab. The FAA has agreed to remove the buildings and cement slab in 2012. No military ranges were ever constructed on or near the property. The entire site with the exception of Area B is characterized by mesquite stabilized, coppice dune habitat which is very common in this general area of the Chihuahuan Desert.

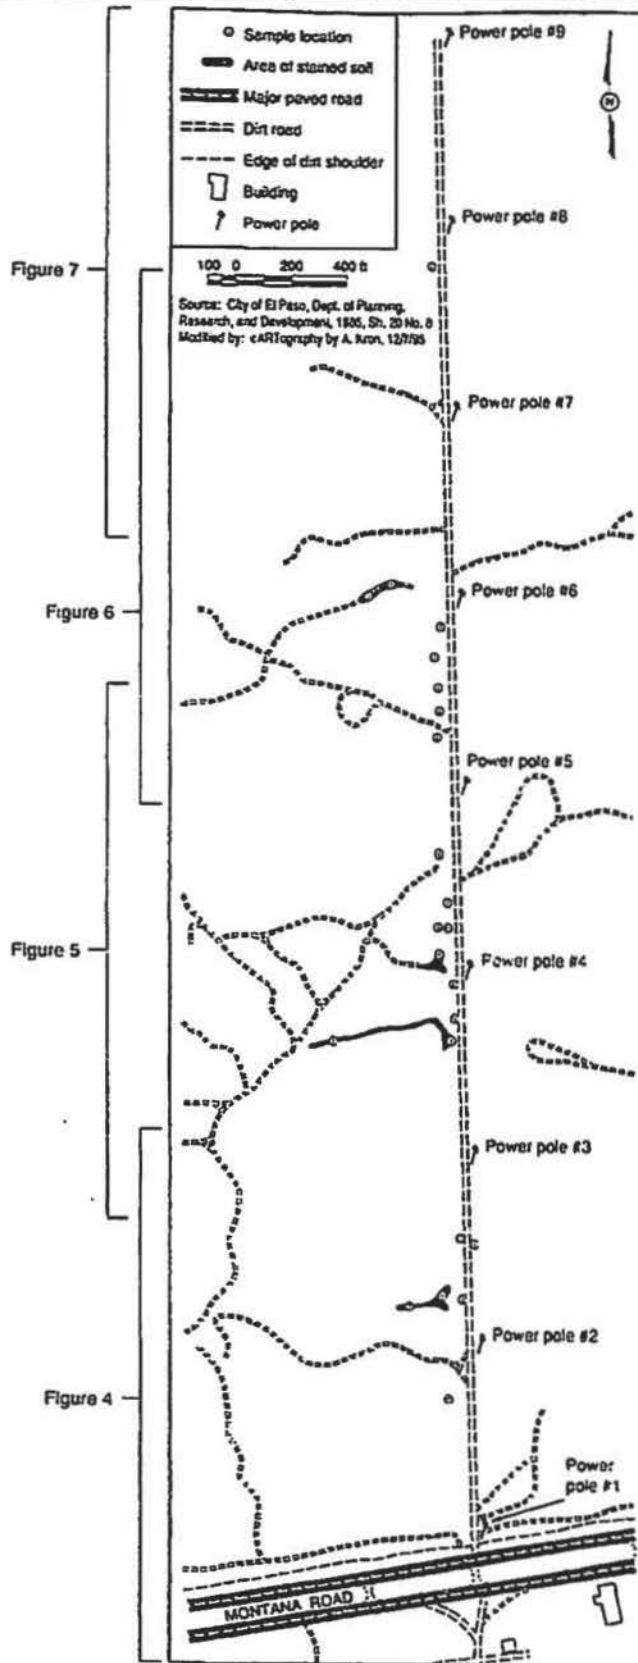
Figure 3. Index map for area of investigation at the Rubble Dump Site, Fort Bliss, Texas.  
 GOLDR ASSOCIATES INC. FOR DBS JV/BOHANNAN-HUSTON, INC.

Fifteen soil samples (RDS-1 through RDS-11, and RDS-25 through RDS-28) were collected from black stained soil associated with releases of POL or other unknown liquids, and from beneath burnt construction debris. Thirteen samples (RDS-12 through RDS-24) were collected from roofing shingles and other construction materials. Sample type and location details are presented in Table 6. All sampling locations are illustrated on the index map for approximately two-thirds of the area of investigation for the Rubble Dump Site in Figure 3. The map only illustrates part of the area of investigation because no samples were collected north of power pole #9. The index map is broken down into four additional figures (Figures 4 through Figure 7) to illustrate more detail and sample location numbers.

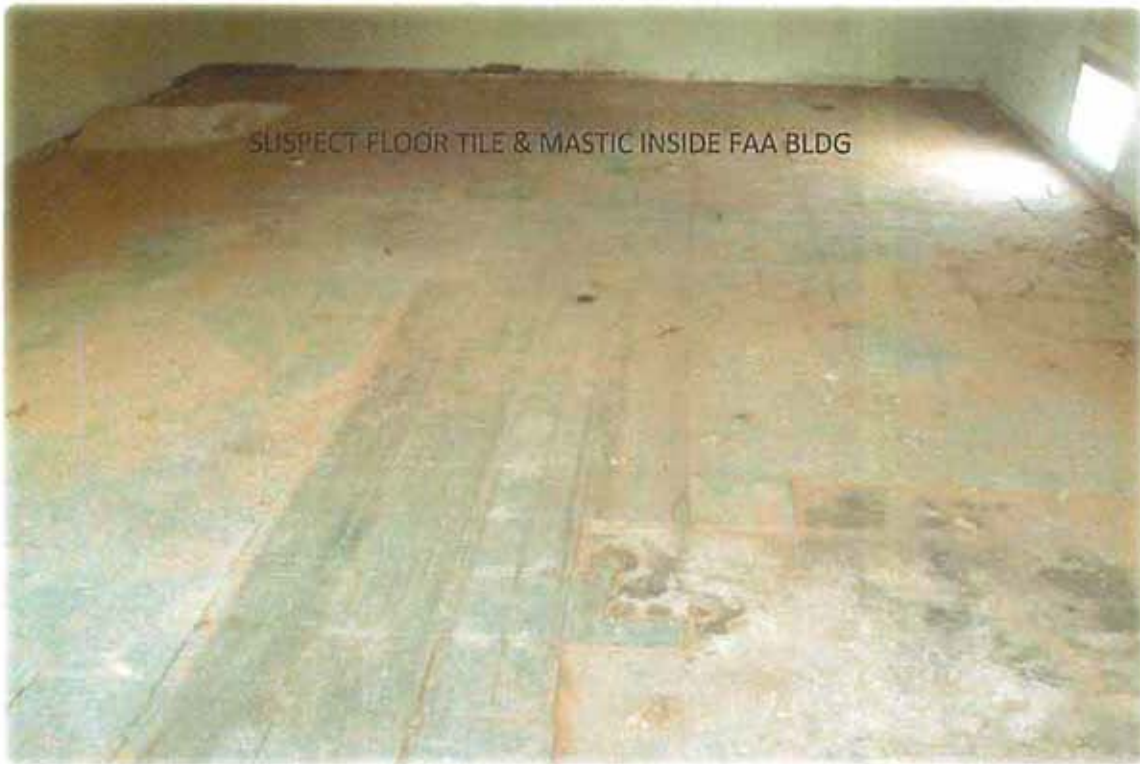
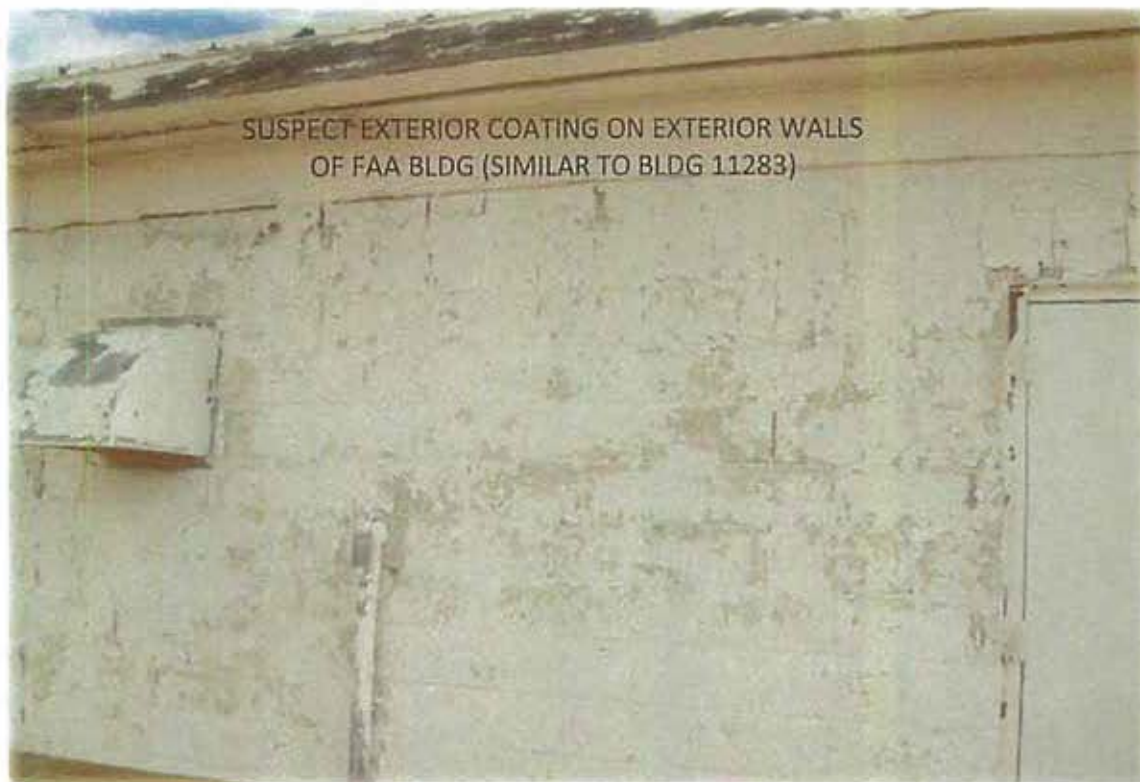
SMALL METAL STORAGE BLDG E. OF FAA BLDG WITH SUSPECT EXTERIOR COATING

*According to 40 CFR, part 61, Subpart M, NESHAP (National Emissions Standards for Hazardous Air Pollutants), an asbestos survey must be performed prior to any demolition or renovation activities. Samples should be taken from the materials mentioned above and submitted for testing, including a TCLP (Toxicity Characteristic Leachable Procedure), prior to demolition. If any of these materials are identified to contain asbestos, abatement should be undertaken by a licensed asbestos contractor with certified personnel trained to perform this type of work.*

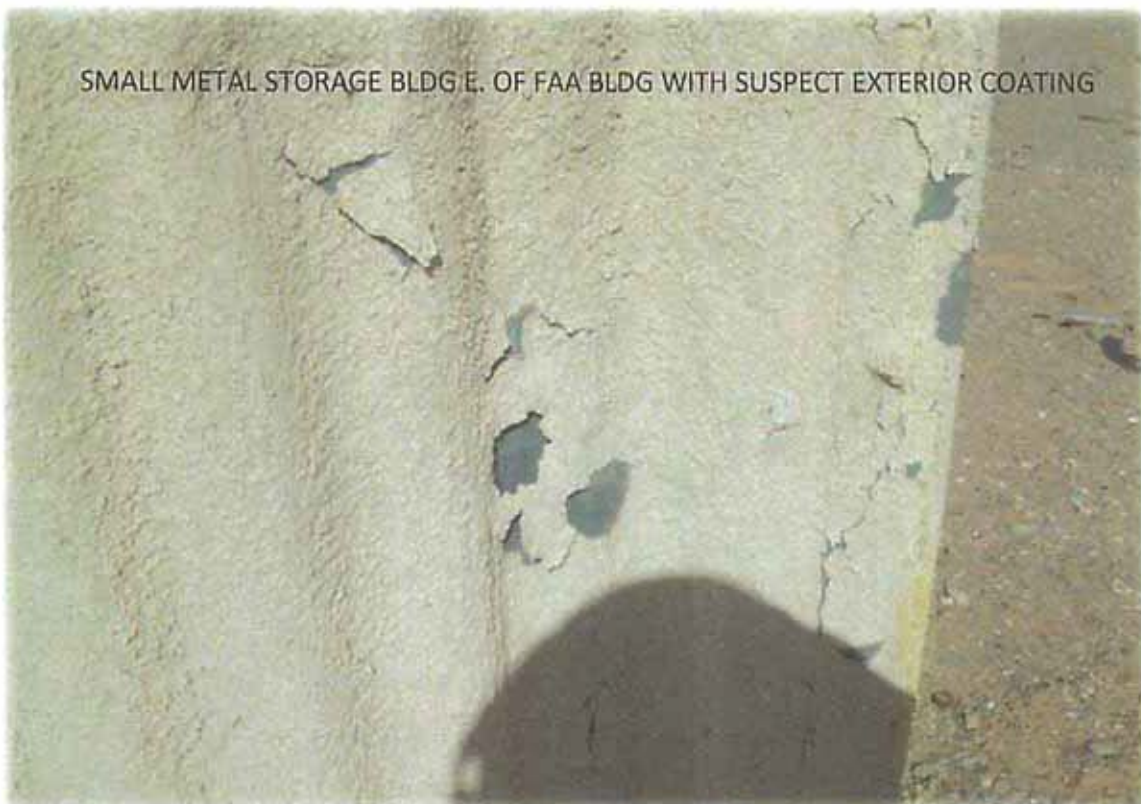
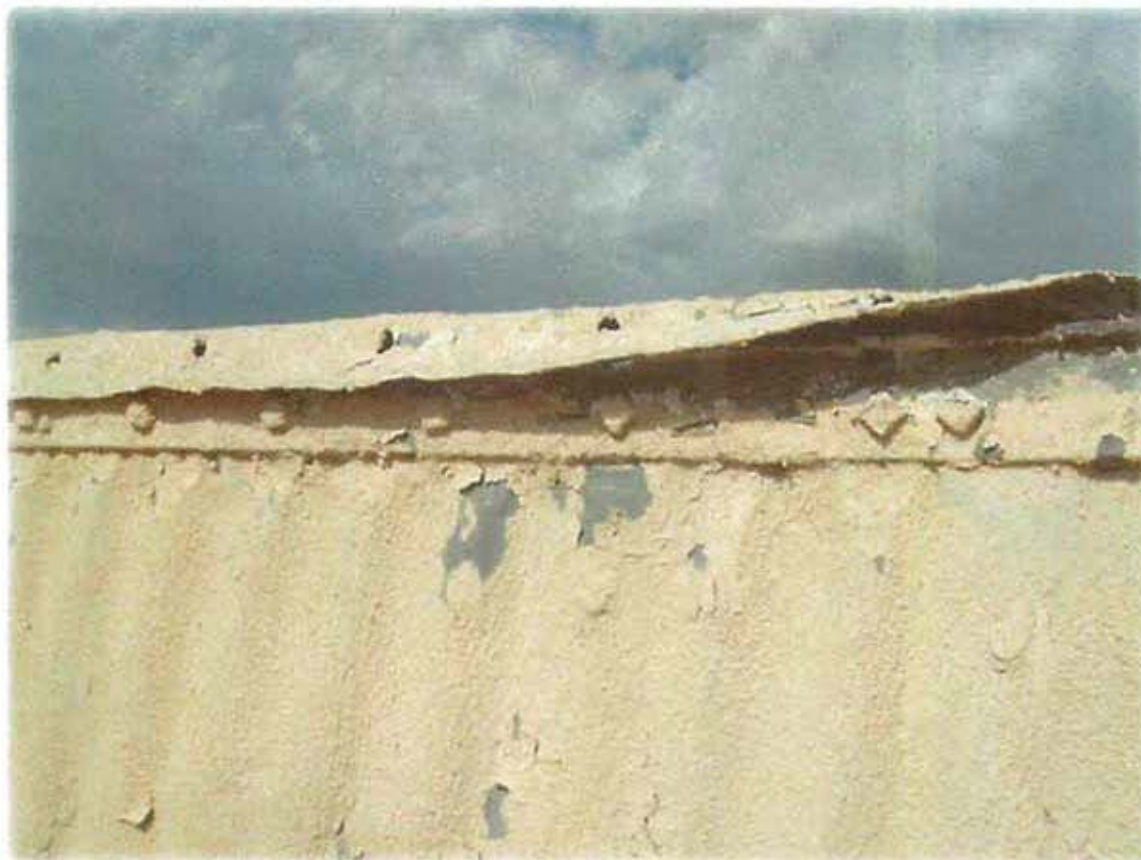
*During our site visit, we discovered three locations of concern with potential asbestos-containing materials. Location 1 is an abandoned FAA building. Green floor tile with black mastic is present throughout the structure. In many sections, the floor is still intact, but in other areas the tiles is crumbling off and several broken pieces are on the ground outside. The roofing materials are also suspect, and the texture on the exterior walls and interior overspray may contain asbestos. Location 2 is a small metal storage building located east of the primary FAA building. This structure has the same type of exterior texture and overspray on the interior as the building at Location 1. Location 3 is south of the abandoned FAA building and consists of a concrete slab with broken floor tiles, with black mastic on the back, scattered throughout the surrounding area. Roofing materials which may contain asbestos were also present at this location.*

CONCRETE SLAB S. OF FAA BLDG WITH DAMAGED FLOOR TILE & MASTIC  
AND SCATTERED THROUGHOUT

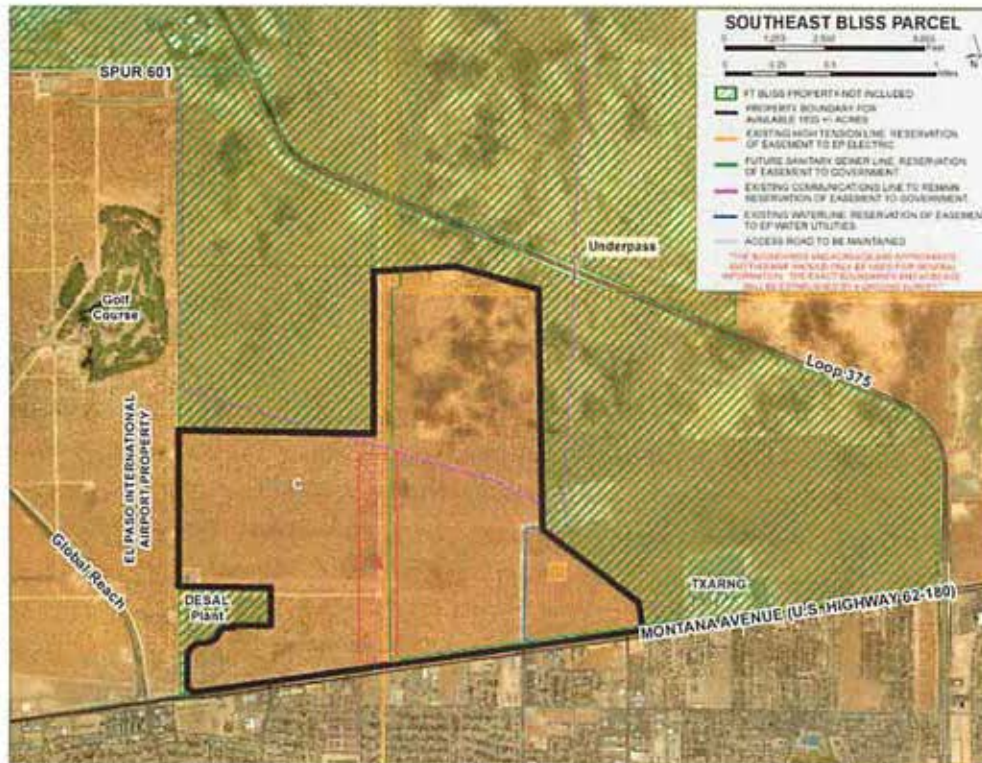
Figure 2. Site Map of Southeast Parcel (Subject Property).

The FAA conducted a Phase I Environmental Due Diligence Audit following the completion of the removal of their decommissioned facility in Area B (in Figure 2) in September 2012. No recognized environmental conditions were revealed in connection with the property, so Area B is also considered to be Category 1: An area where no release of hazardous substances or petroleum products has occurred, including no migration of these substances from adjacent properties.

The remainder of the Subject Property, Area C which consists of approximately 1,490 acres, does not have a history of contamination by hazardous chemicals or from other sources, and no significant cultural resources or natural resources are present. Per Army Regulation 200-1, Area C is also considered to be Category 1 as an area where no release of hazardous substances or petroleum products has occurred, including no migration of these substances from adjacent properties.
